“CSS” style ClampStar

Due to popular demand, CCI has developed the New “CSS” style ClampStar units for use on Deadends and Suspension Clamp applications! Made with a single conductor leg, the new unit installs in minutes, the same as the traditional ClampStar units that are installed over splices.

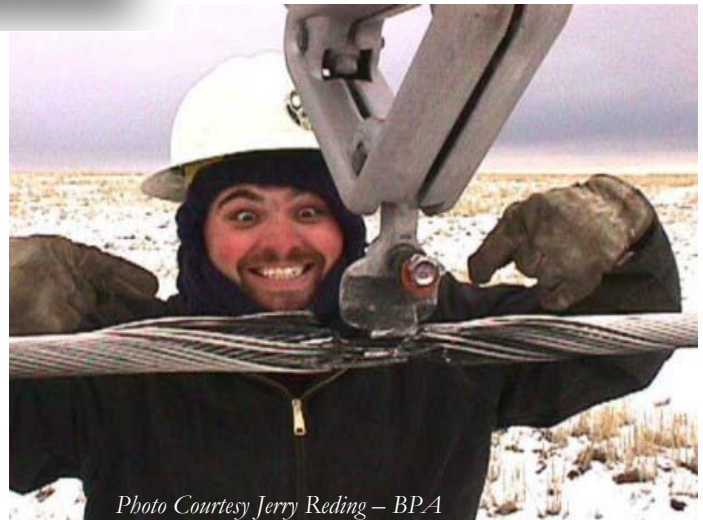
Photo Courtesy Jerry Reding – BPA

In more typical situations (and perhaps less humorous) the resulting fatigue, at the mouth of a bolted deadend, or suspension clamp serves to severely compromise the mechanical and electrical integrity of the conductor; the traditional method of cutting in a section of conductor with two splices is several times more expensive and much more time consuming than installing a ClampStar.

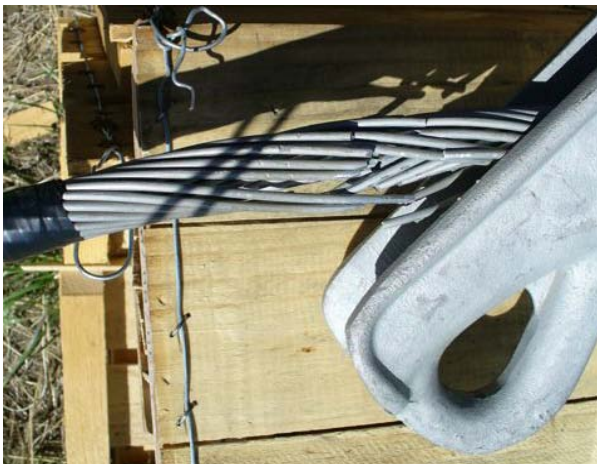
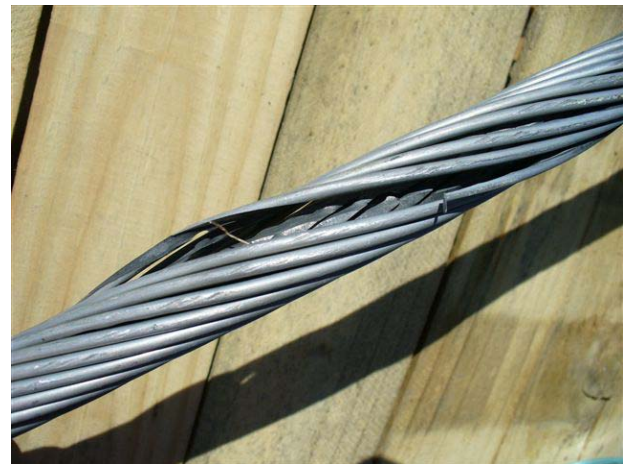
Broken and severely worn strands inside bolted, quadrant style deadends

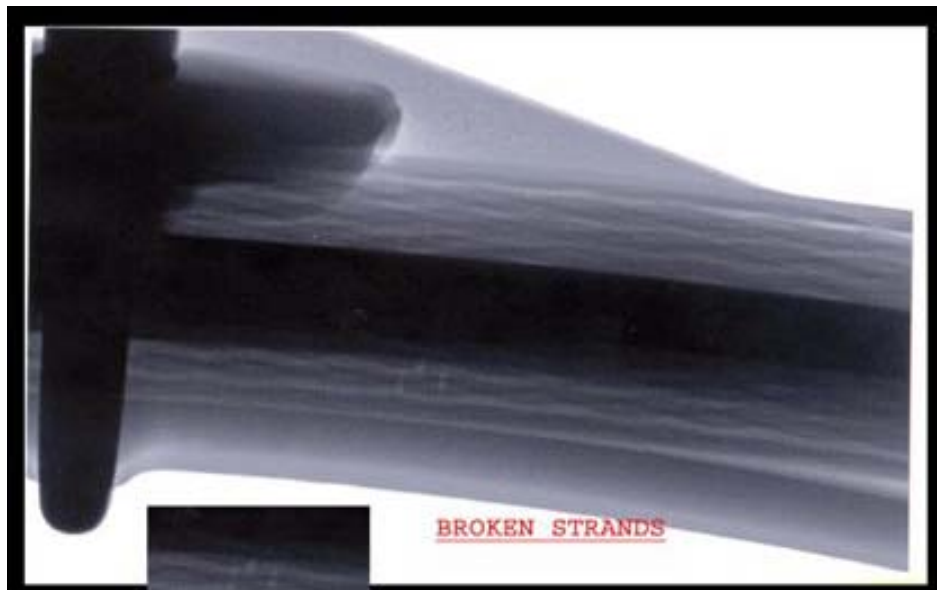
Broken Strands inside standard suspension clamp. X-Ray Photo Courtesy USAirmobile

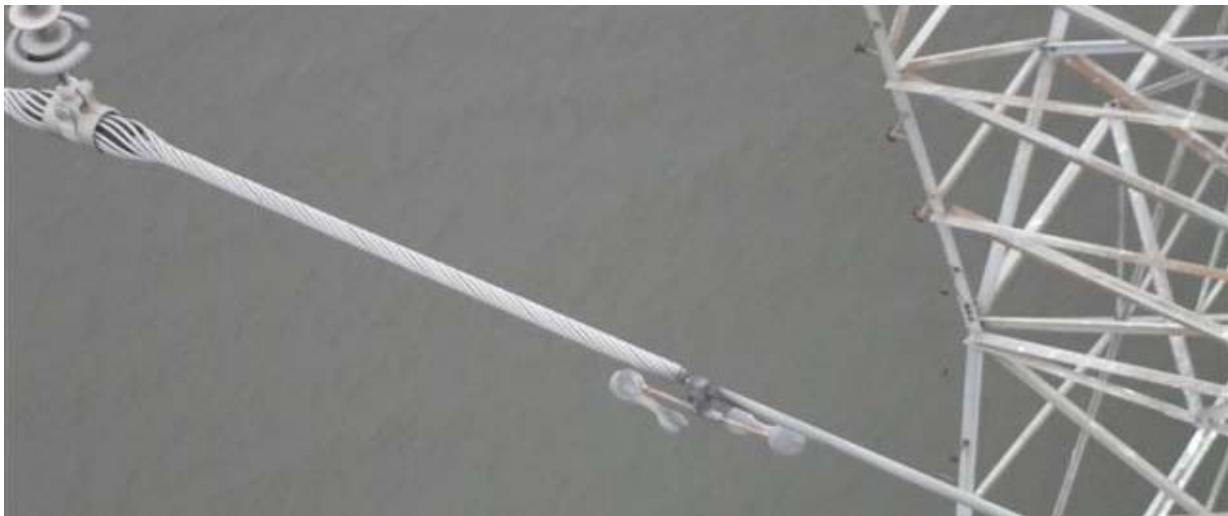
Attempted correction to fatigue at rod ends by placing dampers adjacent breakage locations unsuccessful

In many installations, where helical rods have been employed in suspension applications, fatigued/broken strands have been found at the end of the rods, or underneath them.

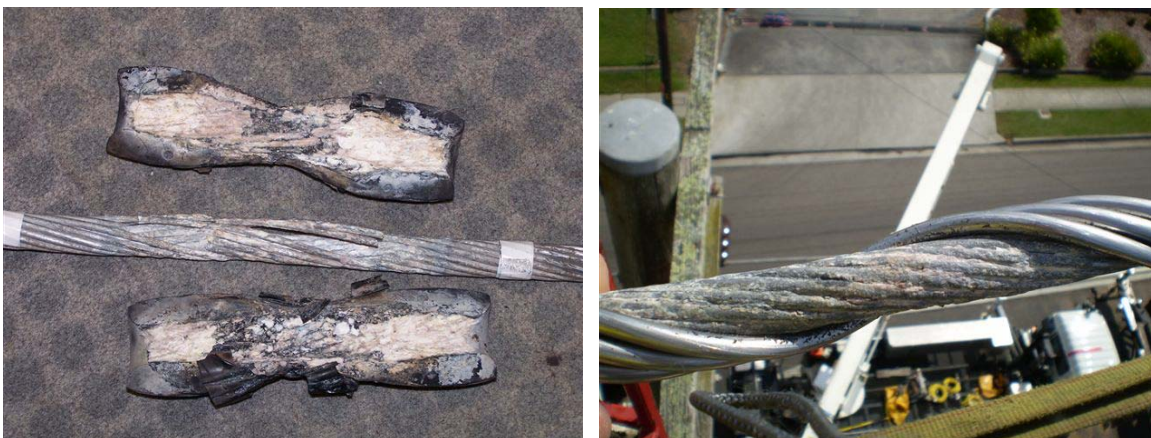
Severely corroded condition of conductor under helical rod suspension applications

In some instances, severe corrosion has occurred within the confines of the elastomeric inserts of some suspension systems, as well as under the rods, particularly where inhibitor was not used.

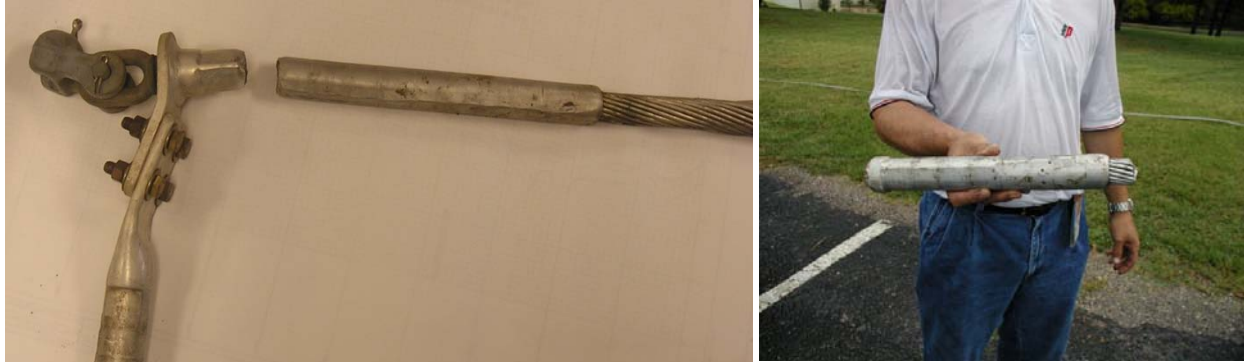
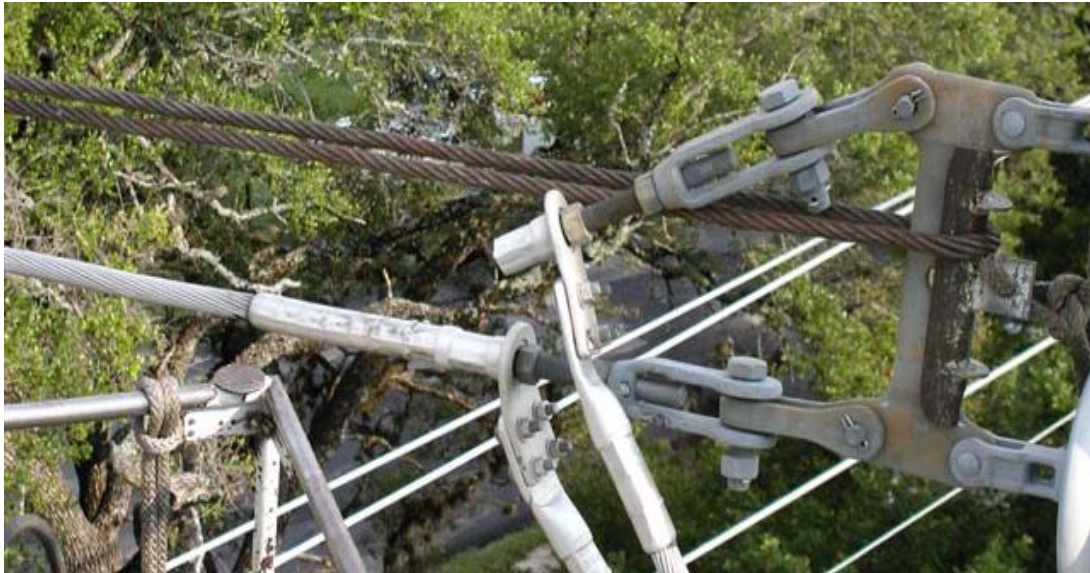
Typical catastrophic failure examples of single die compression deadends

Of course, typical mechanical failures of compression style deadends are also remedied by the simple, fast, and inexpensive application of a “CSS” style ClampStar!

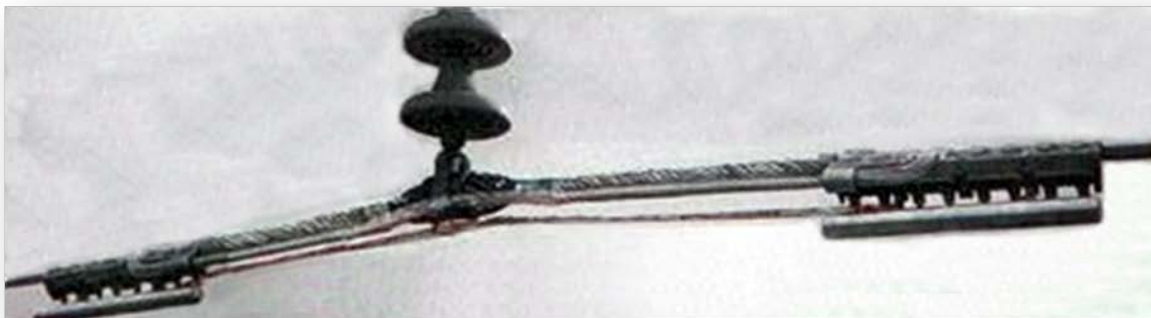
Illustration of CSS-1108-040 with Safe-T-Link and Corona Shields on AGS Type Suspension

With the exclusive ClampStar ‘Safe-T-Link’ mechanical integrity can also be restored on aged deadends or suspension clamps where a high percentage of conductor stranding has broken due to vibration and fatigue.
