## Inner Workings of an Automatic Splice and Using ClampStar as a Safety Tool

Carl R. Tamm

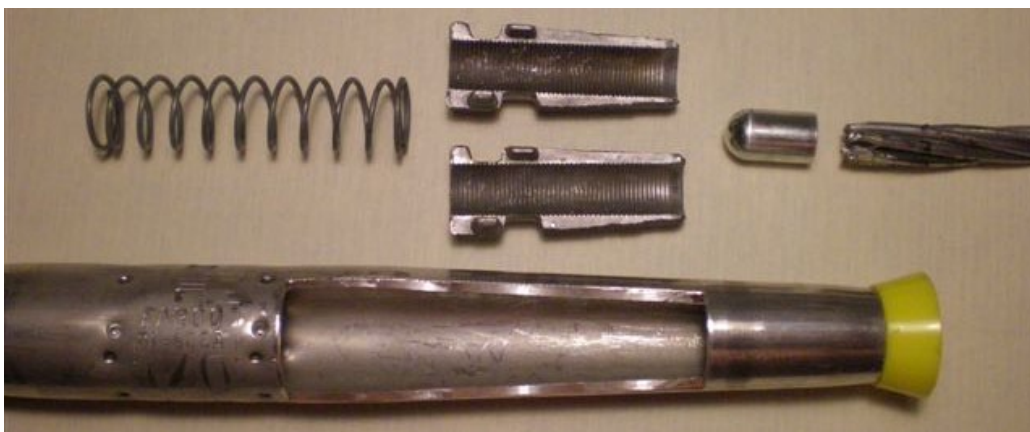
The following is a picture of the “guts” of one side of an automatic – the other side is the same.

Beginning at the upper left and moving clockwise, we have (a) the spring, which provides a forward thrust to the jaw assembly during installation, (b) two jaws which interlock and make up the “jaw assembly”, (c) the pilot cup, which captures the ends of the conductor strands, and maintains their position (keeps them together) during the installation, and at the bottom, the yellow component is the “funnel guide” which serves to hold the pilot cup inside the assembly and guide the stranded ends of the conductor into the pilot cup – all within the tapered body of the splice.

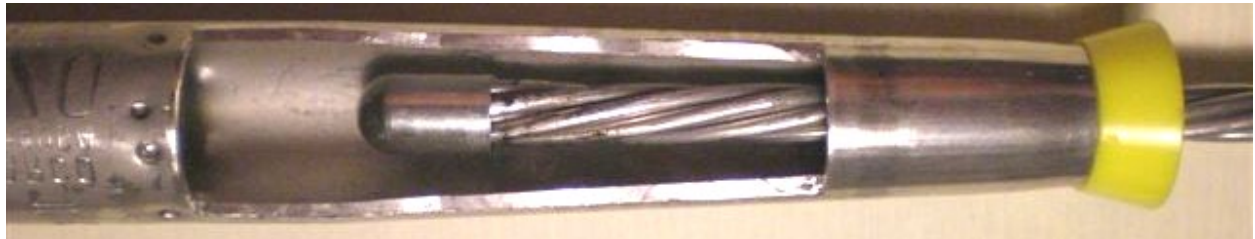
To illustrate the action of the pilot cup, the following photo shows how the conductor, once inserted through the funnel guide, fits within the confines of the pilot cup.

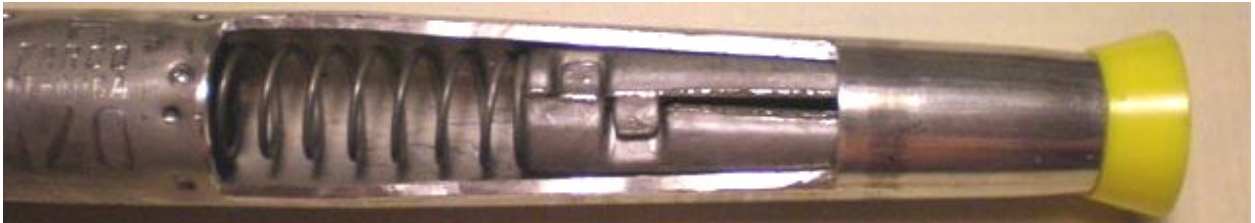
Prior to insertion, having this side cut out from the splice, one can see the position of the jaws, urged forward by the force of the spring, awaiting insertion of the conductor.

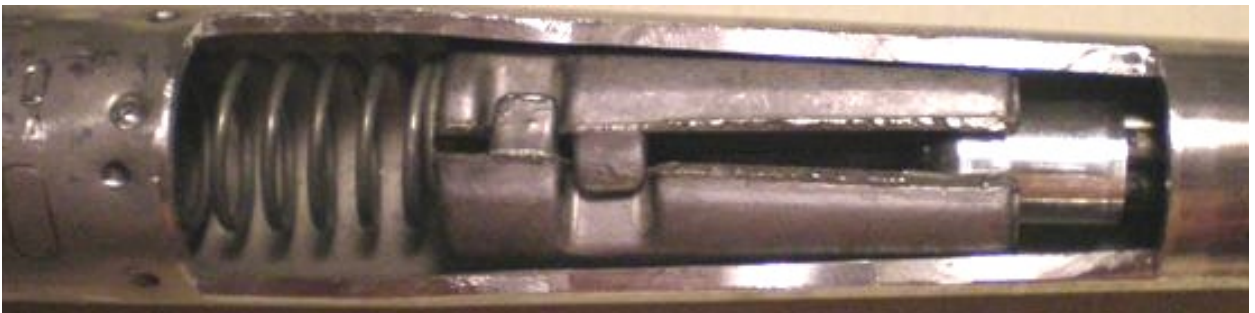
Upon insertion of the conductor, having picked up the pilot cup as it passes through the funnel guide, the “resistance” that is felt during installation is the force required to push the jaw assembly backward against the spring.

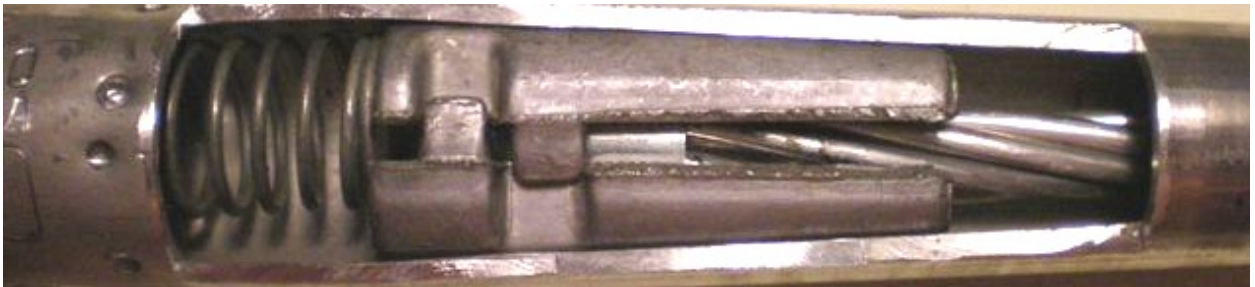
As can be seen, the pilot cup serves to maintain the conductor’s position, centered within the jaws as it is pushed toward the center of the splice.

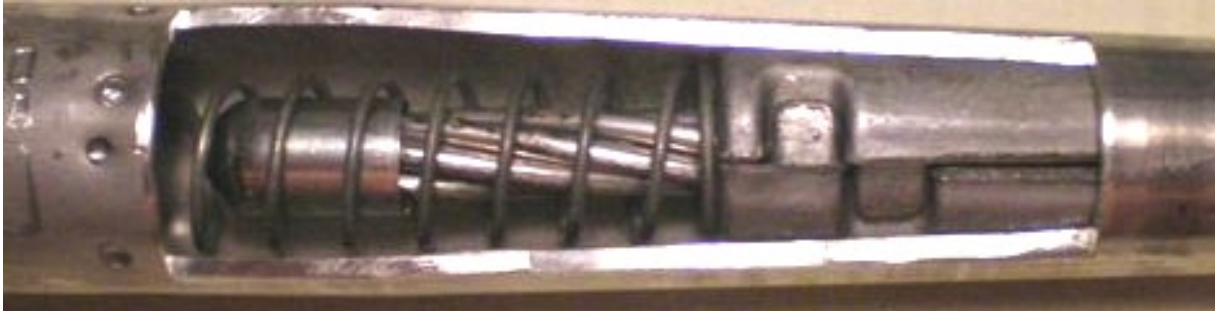
Properly installed, the conductor will carry the pilot cup completely through the jaws, to the center of the splice. Because the pilot cup must contain the entire conductor, it is obviously of larger diameter than the conductor, and as can be seen in the following photo, upon passing the pilot cup completely through the jaws, the jaw assembly will “spring” forward, and the taper of the body will force the jaws into intimate contact with the conductor! Additional tension on the device will serve to further “seat the jaws” and urge them into increased forced contact with the conductor.

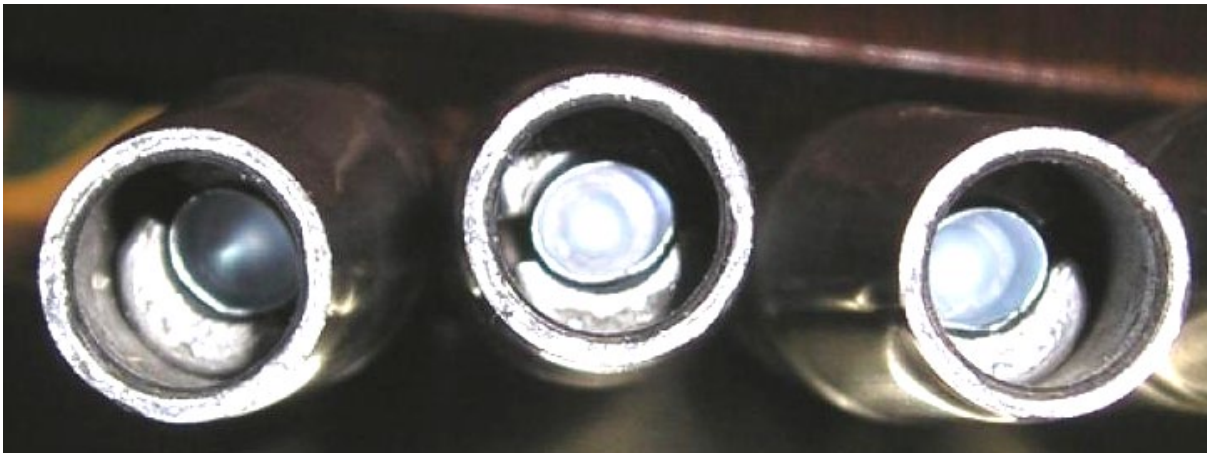
The result is that of the following photos. In the instance of the first photo, insufficient force was provided to drive the pilot cups into the jaws, and the conductor was simply not gripped. If this occurs, the lineman will immediately recognize there is a problem, and take action to correct that, by installing another splice.

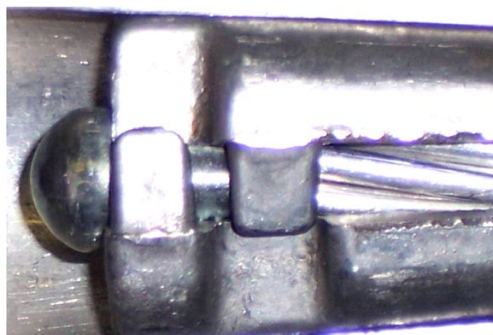
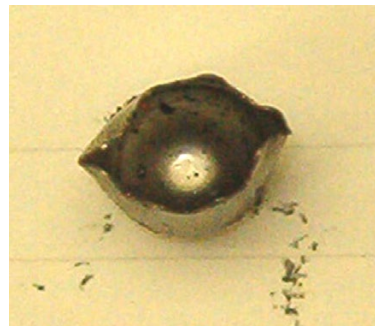
However, in the instance that follows, the pilot cup has passed almost to the end of the jaws, which is the most dangerous situation, as the tips of the jaws may capture the conductor, leading the installer to believe that the splice is made adequately, and the conductor may withstand the initial tension of the line, but the jaws are prevented from closing completely on the conductor by the invading pilot cup! In such instances, the splice may be left in service for days, weeks, or even years, before some event jostles the line sufficiently or components of corrosion allow the conductor to slip out! This condition may be impossible to detect with infrared techniques, depending on the current load on the line.

A second type of insertion error occurs from time to time, when upon inserting the conductor, the lineman pulls it back a bit (possibly to get a better grip because it was obvious that the conductor did not go it far enough – such as the condition in the previous photo and the pilot cup does not come back, as it is held in the jaws. The purpose of the pilot cup is to keep the ends of the strands together, and assure that they all pass completely through the end. In the scenario where the conductor is retracted as much as ½ inch, the strands can escape from the pilot cup, and one may erroneously slip through the side between the jaws. In this instance, although the conductor may be fully inserted, the errant strand between the jaws prevents them from closing completely, and because it is not within the bundle, the overall diameter is reduced and again, the conductor can slip from the grasp of the jaws.

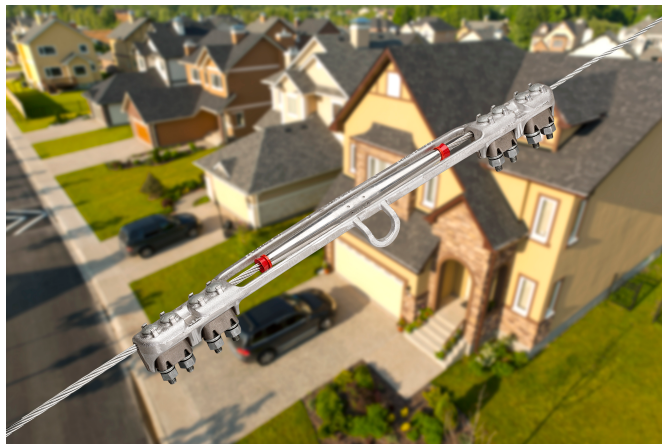
Have you ever looked up as you were driving, and noting a splice in the conductor passing over the road, wondered if that splice was one of many that, although it is there today, may have been improperly installed, and could “let go” at any moment with no warning? Perhaps one might sleep a little better if they saw a ClampStar covering that splice, knowing that one connector had been “corrected”!

Placing a ClampStar on the line in a gentle fashion allows both the electrical and mechanical safety to be applied at the same time, and is faster and safer to install. If the splice appears bad, i.e., has burnt funnel guides or has evidence of obvious expulsion of contaminants (looks like black grease) running out of it, perhaps it would be wise to simply leave the ClampStar in place!
