“CSS” style ClampStar

Due to popular demand, CCI has developed the New “CSS” style ClampStar units for use on Deadends and Suspension Clamp applications! Made with a single conductor leg, the new unit installs in minutes, the same as the traditional ClampStar units that are installed over splices.

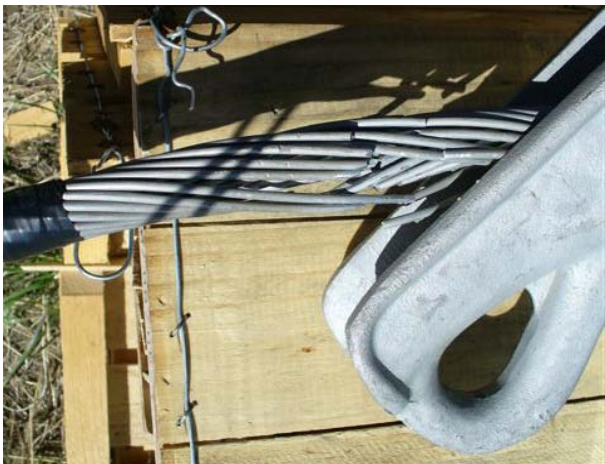
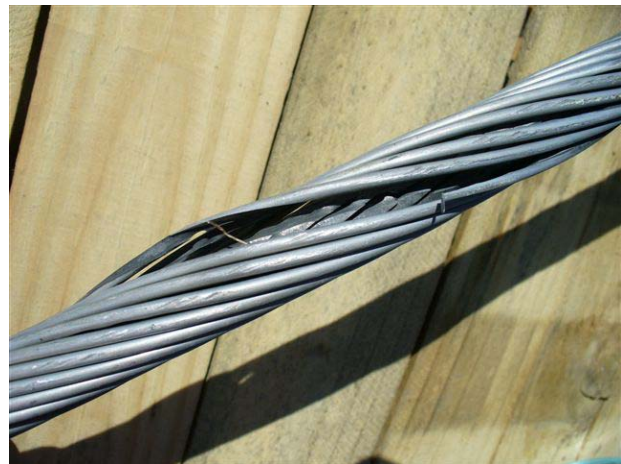
Broken and severely worn strands inside bolted, quadrant style deadends

In more typical situations (and perhaps less humorous) the resulting fatigue, at the mouth of a bolted deadend, or suspension clamp serves to severely compromise the mechanical and electrical integrity of the conductor; the traditional method of cutting in a section of conductor with two splices is several times more expensive and much more time consuming than installing a ClampStar.

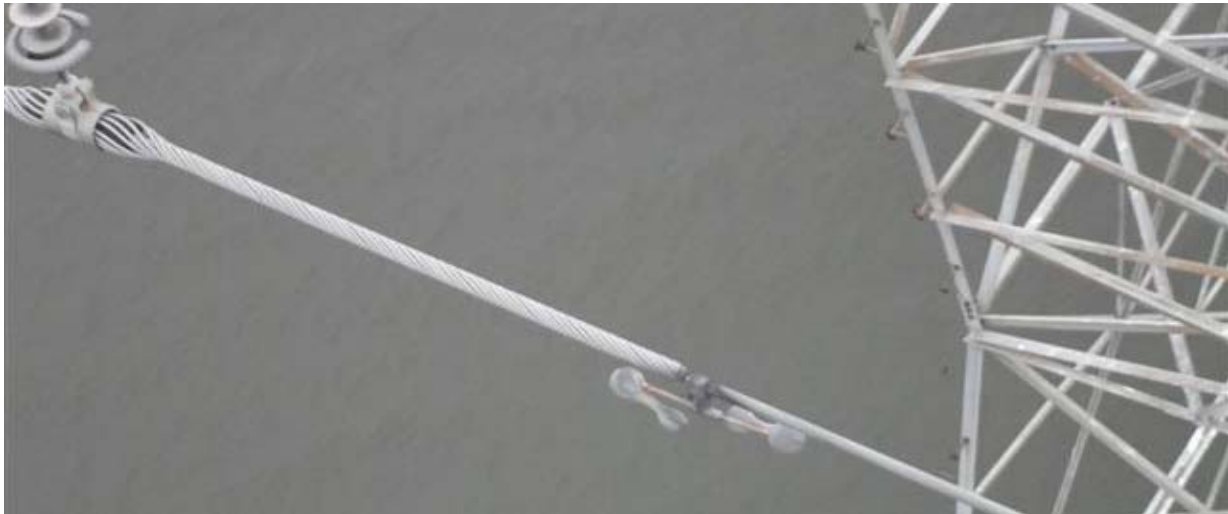
Attempted correction to fatigue at rod ends by placing dampers adjacent breakage locations unsuccessful

In many installations, where helical rods have been employed in suspension applications, fatigued/broken strands have been found at the end of the rods, or underneath them.

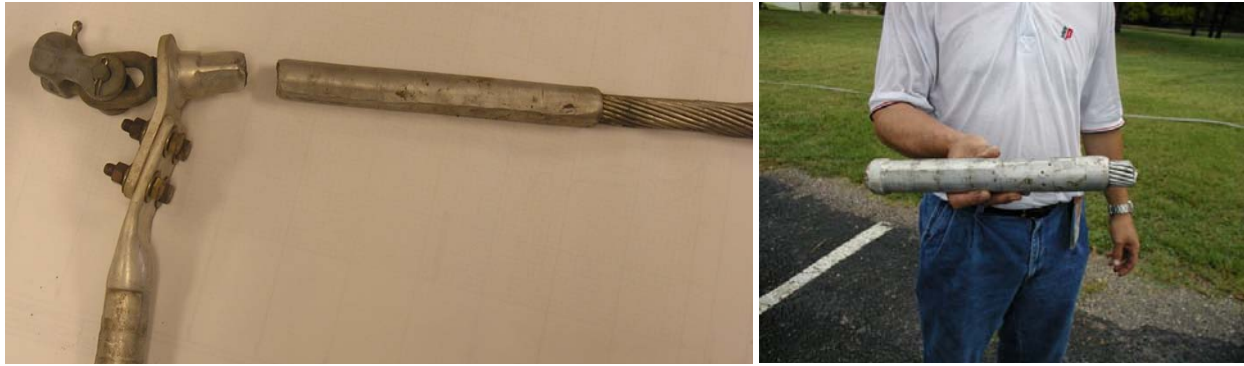
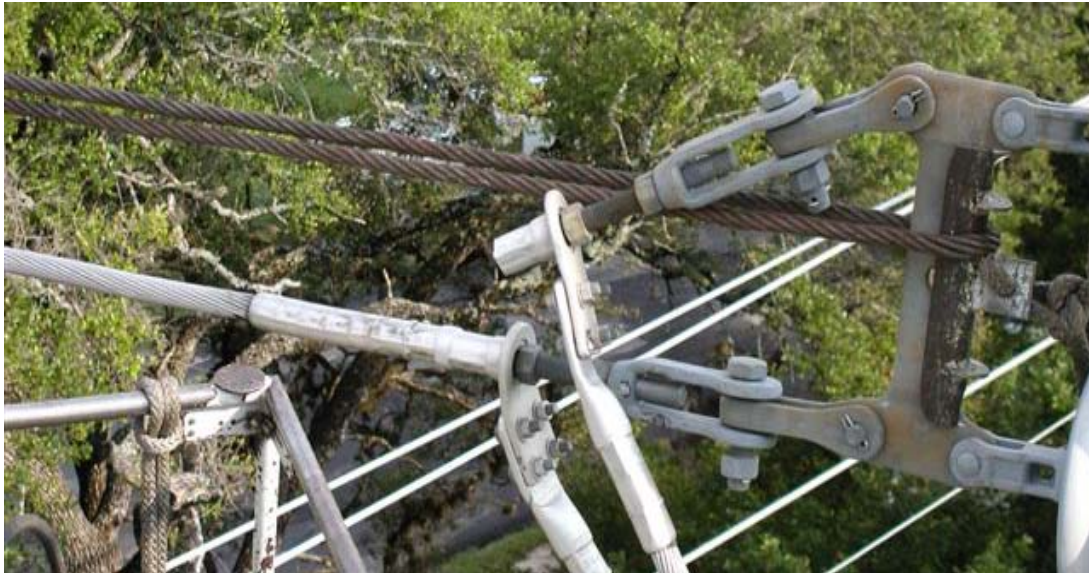
Typical catastrophic failure examples of single die compression deadends

Of course, typical mechanical failures of compression style deadends are also remedied by the simple, fast, and inexpensive application of a “CSS” style ClampStar!
