## CIGRE US National Committee 2022 Grid of the Future Symposium

### **Extending the Life of Overhead Aging Assets with Focus on the Energized Portion of Transmission Line**

**CARL R. TAMM**  
**Classic Connectors, Inc**  
**USA**

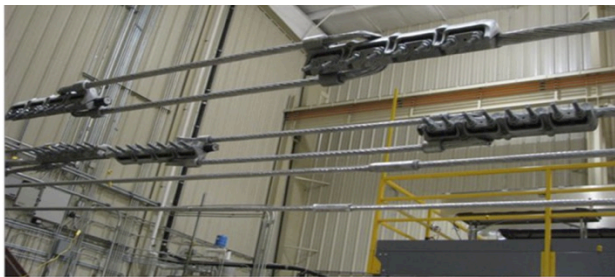
The following photos were taken during testing of EEMS on new 795 Drake ACSR conductors and include the performance of an unprotected splice/joint. The test was conducted, with 2000 thermal cycles, maintaining the conductor in the test loop at 200°C and at a tension of 35.6kN (8000 lbf.) The splice shown was properly installed with proper conductor preparation of scratch brushing, and use of the manufacturer's specified inhibitor, press, dies, and instructions.

***EEMS Under Test – No Connector within***

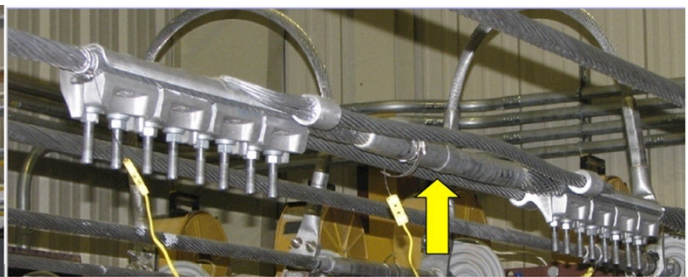
***EEMS installed over failed splice***

The splice/joint shown above did not have the EEMS applied until after it had reached the temperature of 332°C explained in the graph shown on the following page.

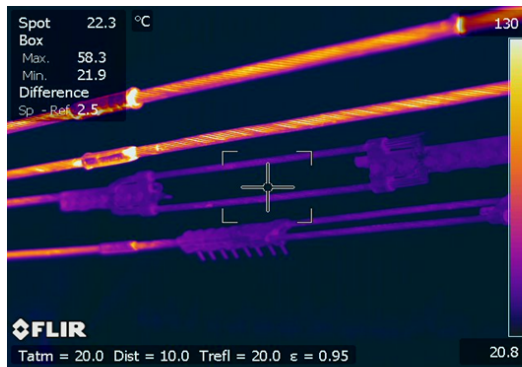
***EEMS Serving Full Mechanical & Electrical***

Note the maximum temperature indicated in the box on the left compared to the right. The left is 58.3°C because the EEMS is carrying the full mechanical and electrical load, as evidenced by the conductor terminated in the ends of the EEMS. The one on the right is only 42.5°C because the old splice/joint is still in place and is carrying a portion of the current, albeit a very small percentage. The Spot temperature on the left is 22.3°C which is the ambient temperature on the back wall of the test lab, while the Spot on the right is on the original connector, now at only 26.5°C, barely above ambient.

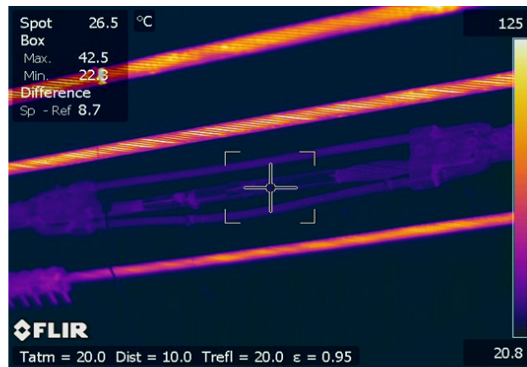
***EEMS Over Failed Mid-Span Joint / Splice***

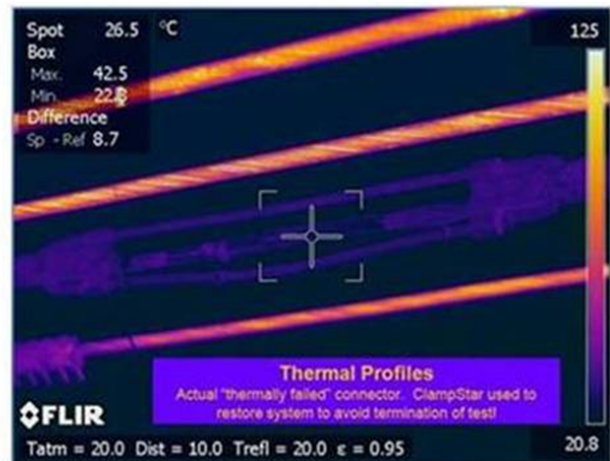
Graph indicating thermal rise of splice, shown in photo to the right, total of 2000 thermal cycles.

The graph above depicts the thermal history of the Mid-Span Joint/Splice, which was properly installed, and as expected began operating at 150°C on a conductor operating at 200°C for a few hundred cycles. The rising slope depicted in the graph is the deterioration (increase in temperature) of the electrical interface. At approximately 1200 cycles, it reaches a peak of 332°C and it began to slip under tension. The EEMS was installed at this point to mitigate the failing connector. Note, that the connector does not just go back to the new condition of 150°C, – it drops to ONLY 42.5°C, and stays there throughout the remainder of the test, for another 800 cycles on a conductor operating at 200°C. Following this 2000 cycle test, after being subjected to these temperatures, this assembly was tested to and achieved full tension.

This clearly illustrates the superiority of the electrical integrity of the EEMS in comparison to replacing a connector. Had the connector been replaced, the replacement connector would have been back to 150°C as the original splice, but due to the conductor being aged through thermal cycling, the thermal escalation curve would have been much steeper than the original splice/joint installed on new conductor. There are several factors that cause the EEMS to operate much cooler. Among them is that they are designed to have lower resistance, which accounts for the lower temperature, however, the remarkable resistance/temperature stability is provided by a high force, resilient contact, with the actual electrical interface being substantially larger than that of a compression type connector.

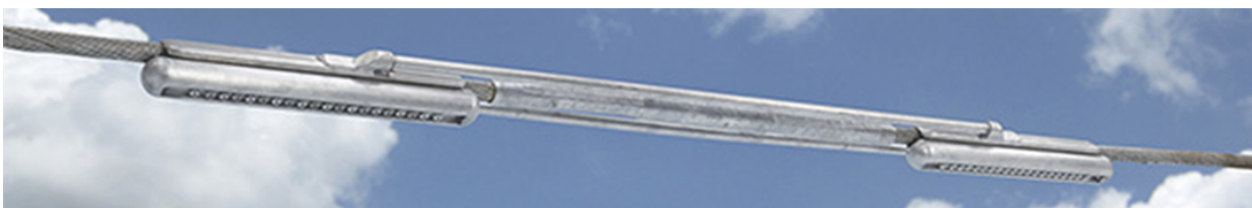
*Transmission Class EEMS rated up to 800kV-AC and 500kV-DC and 250°C Conductor*

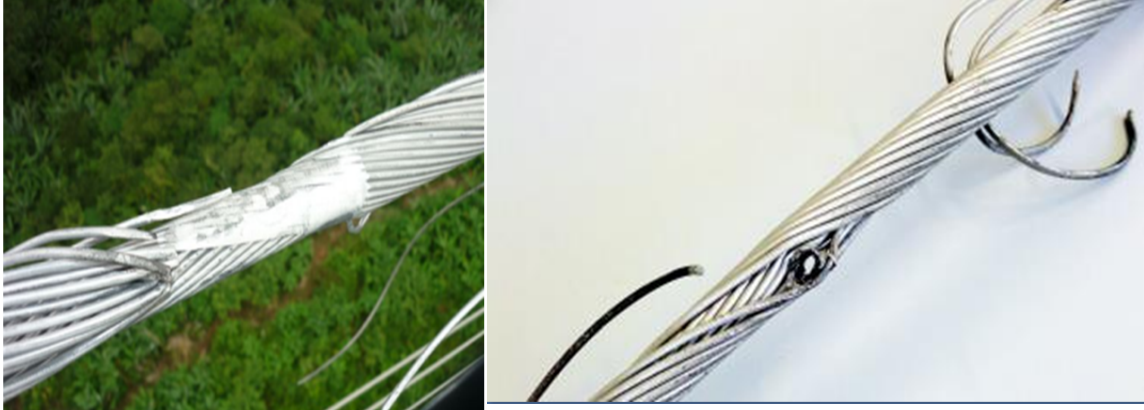
*Abraded Conductor*

*Gunshot Damage*

The resultant damage forces current constriction, driving current through the remaining unbroken strands, which of course results in localized heating and if left unattended will eventually result in local conductor annealing and potentially tensile failure.

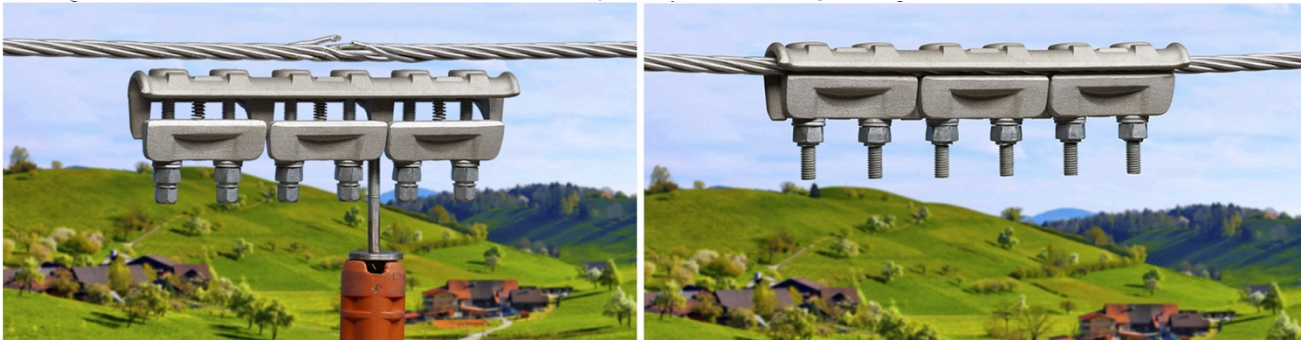
The following illustrations depict the installation of a smaller size CRU installed to restore conductor damage on a distribution line. These are commonly installed on energized lines with hotline tools.

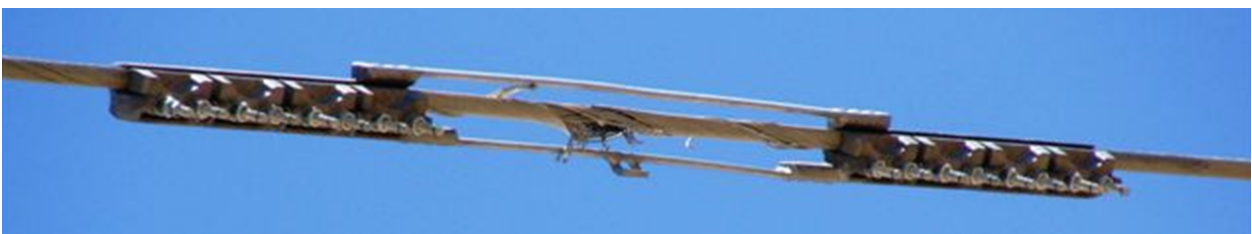
*Gunshot damage restored using an EEMS designed for splice mitigation.*

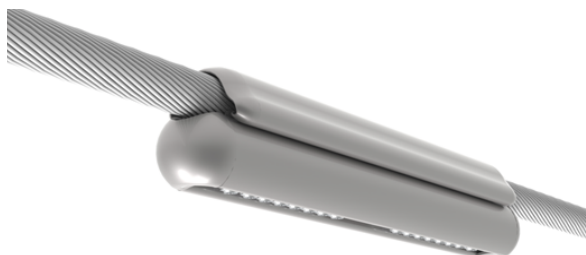
*The body is centered over the damaged area, and the head is slid in place. Torque Limiting Fasteners are tightened until the head shears off, leaving the remaining portion within the corona shielding zone, restoring full mechanical and electrical integrity.*

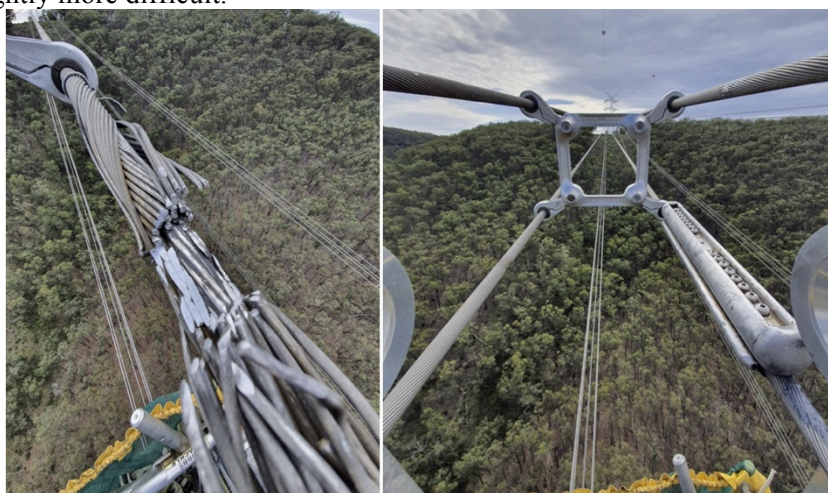
In the photo below, the CRU has been applied upside down. The orientation does not matter with these units, but as it was installed from a cart, it was easier in this fashion, however it would make crossing it later with a cart slightly more difficult.

***EEMS Mitigation of Strand Damage from Spacer-Damper before and after***

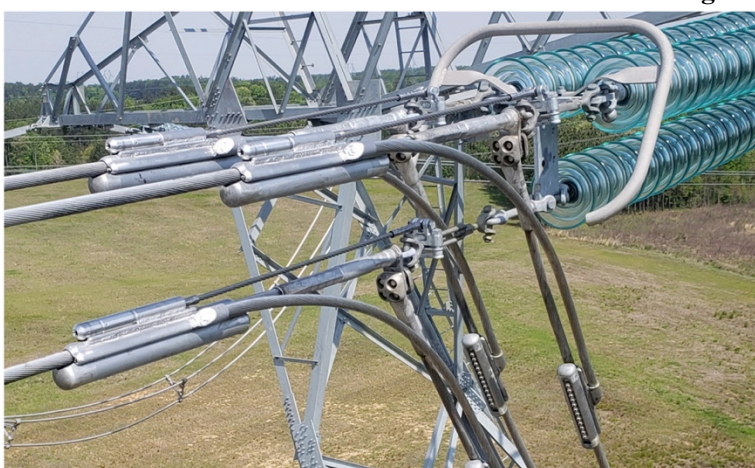
*Photograph above on a tri-bundle 500kV installation*

Similar in design to the EEMS for use on splices/joints, the Deadend Transmission Class units are corona-free up to 800kV AC and 500kV DC and are easily installed on energized lines with bare-hand techniques. They are ampacity rated to operate continuously with conductors operating at 250°C and are suitable for use on any aluminum stranded conductor, including ACSS, ACSR, AAC, AAAC, ACAR, etc.

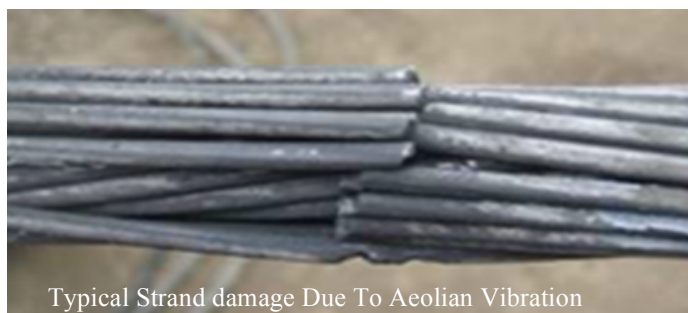
Typical Strand damage Due To Aeolian Vibration

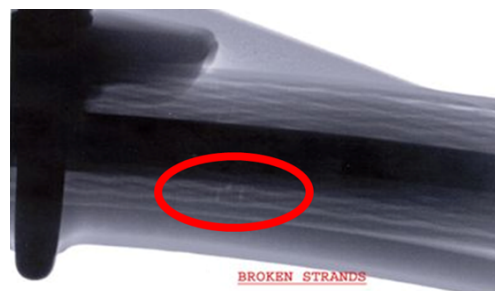
X-Ray of Broken Strand in a Suspension Clamp

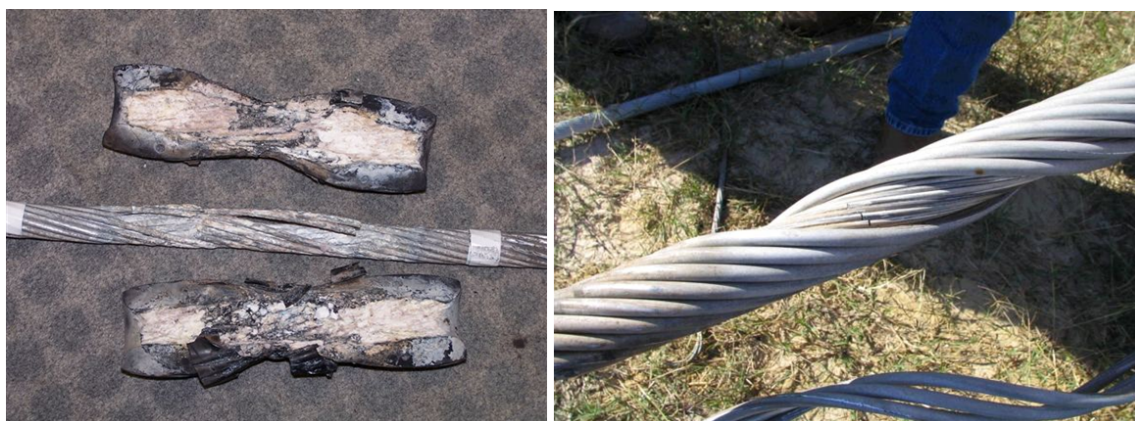
***Damage Strands found inside suspension unit and under rods***

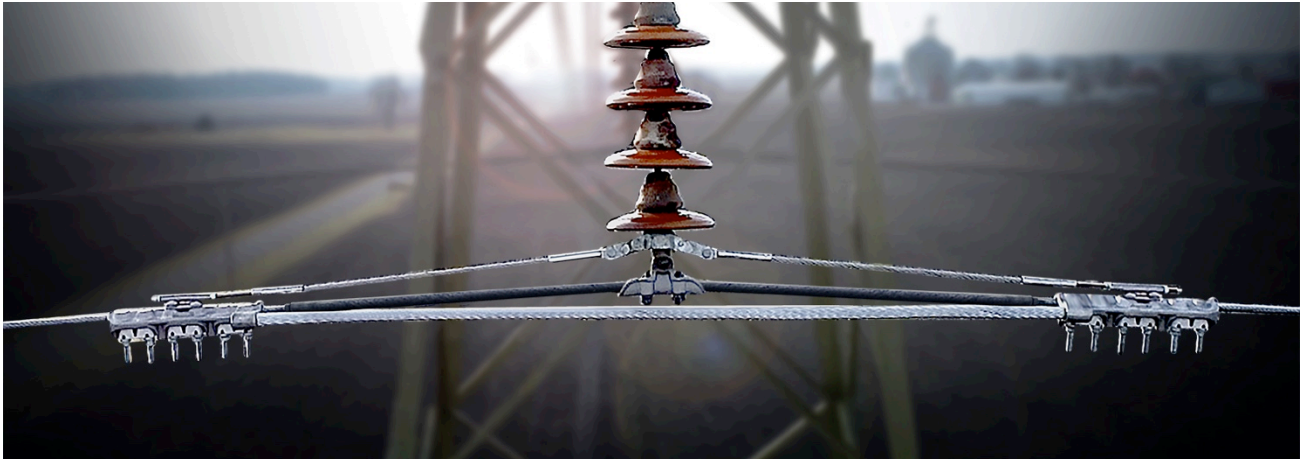
The fitting is easily retrofitted over the ball/socket joint on the bottom of the insulator, providing mechanical attachment points for the stainless-steel tether cables included in the kit. The EEMS body of the kit is designed to attach to locations on the conductor beyond any damaged areas, thus gripping the conductor mechanically, and simultaneously providing a superior electrical connection. A jumper conductor attached between the EEMS attachment heads provides an alternate electrical path, thus shunting the current around the damaged area of the system. This allows the damaged area to cool to within 3-4°C of ambient and assures that further degradation will be eliminated.

*Typical BallCap application, 115 kV 477 Hawk with armor rods – broken strands under rods*
